MIKE BAILEY PAINT SERVICES – ENERGY STAR PROJECT PROFILE

Bonnie Doon, Victoria Holiday Home

Project: Roof Restoration

Time: Early 2010

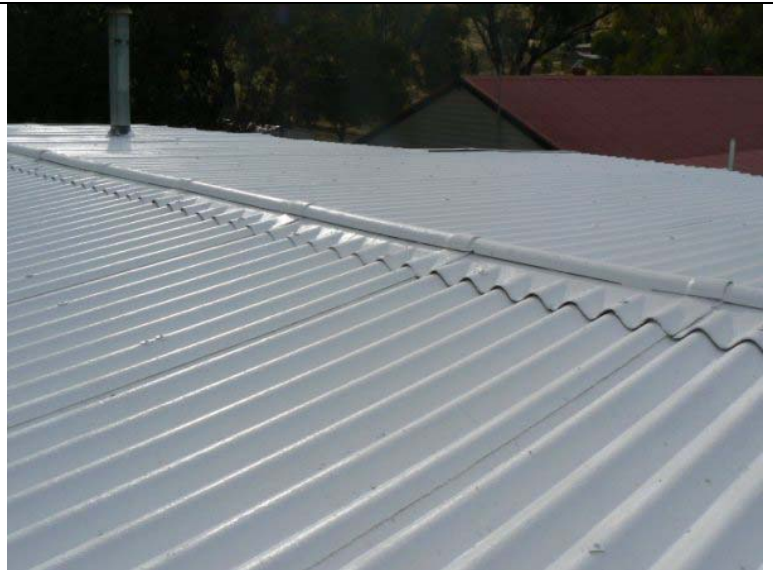
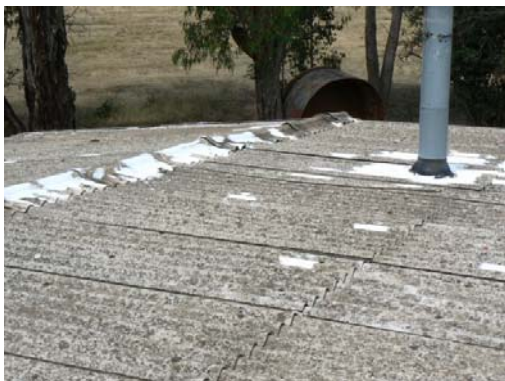
Before shots – cracked asbestos roof

Client contacted us with a leaking Asbestos roof on his holiday home in Bonnie Doon. One sheet of asbestos was cracked and needed to be repaired and sealed. The crack was tapped and the entire roof surface was encapsulated in **Energy Star EC 100 Heat Reflective Paint**. This work was completed following the strict guide lines of the Australian Standard for Asbestos roofing.
